Rock Lake
Aquatic Vegetation Management Plan
2006 Update
February 14, 2007

Prepared for:
Rock Lake Conservation Club
1208 S. Lakeshore Drive
Akron, IN 46901

Prepared by:
Aquatic Control, Inc.
PO Box 100
Seymour, Indiana 47274

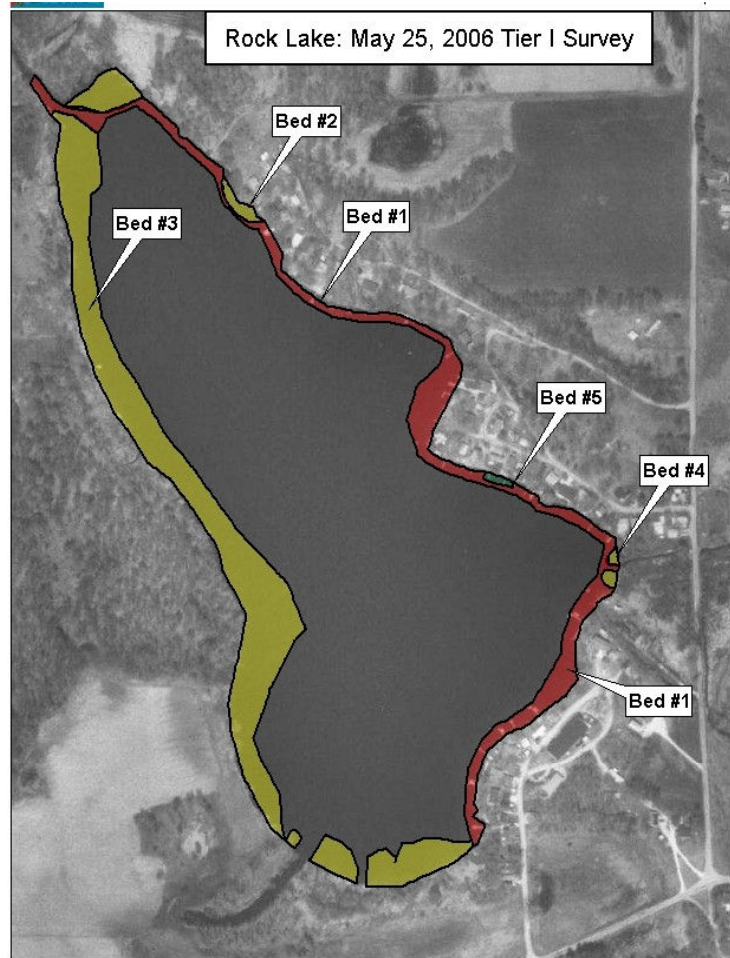
Figure 1. Tier I Plant Beds, Rock Lake, May 25, 2006

On May 25, 2006, a Tier I survey was completed on Rock Lake. The Secchi depth was found to be 1.5 feet and plants were growing to a depth of 4.0 feet. The survey revealed five distinct plant beds totaling 12.7 acres (Table 1 & Figure 1). Eight different species were observed.

Plant bed 1 was located along the eastern side Rock Lake (Figure 1). It was determined to be 3.7 acres in size. A total of seven species were observed. White water lily (*Nymphaea tuberosa*) was the dominant plant species. Coontail (*Ceratophyllum demersum*), sago pondweed (*Potamogeton pectinatus*), common cattail (*Typhia latifolia*), spatterdock (*Nuphar tuberosa*), water willow (*Justicia Americana*), and bulrush (*Scirpus spp.*), were present at the lowest abundance rating (less than 2%).

Plant bed 2 was located along the northeast shoreline of Rock Lake and was comprised entirely of rooted floating vegetation (Figure 1). This plant bed was determined to be 0.1 acres. Spatterdock was the most abundant species with a score of 4 (>60% abundance) followed by white water lily with a score of 2 (2-20% abundance).

Plant bed 3 was located on the entire western shoreline (Figure 1). This plant bed was determined to be 8.7 acres. A total of five plant species were observed in plant bed 3. This bed was comprised of rooted floating and emergent vegetation. Spatterdock was the most abundant species followed by white water lily, bulrush, water willow, and common cattail.

Plant bed 4 was located on the eastern side of Rock Lake and was determined to be 0.1 acres (Figure 1). Spatterdock was the most abundant species followed by white water lily, bulrush, and common cattail.

Plant bed 5 was located on the eastern shoreline (Figure 1). This plant bed was determined to be 0.1 acres. Plant bed 5 was comprised entirely of submersed vegetation. Largeleaf and sago pondweed were the only species observed in this bed.

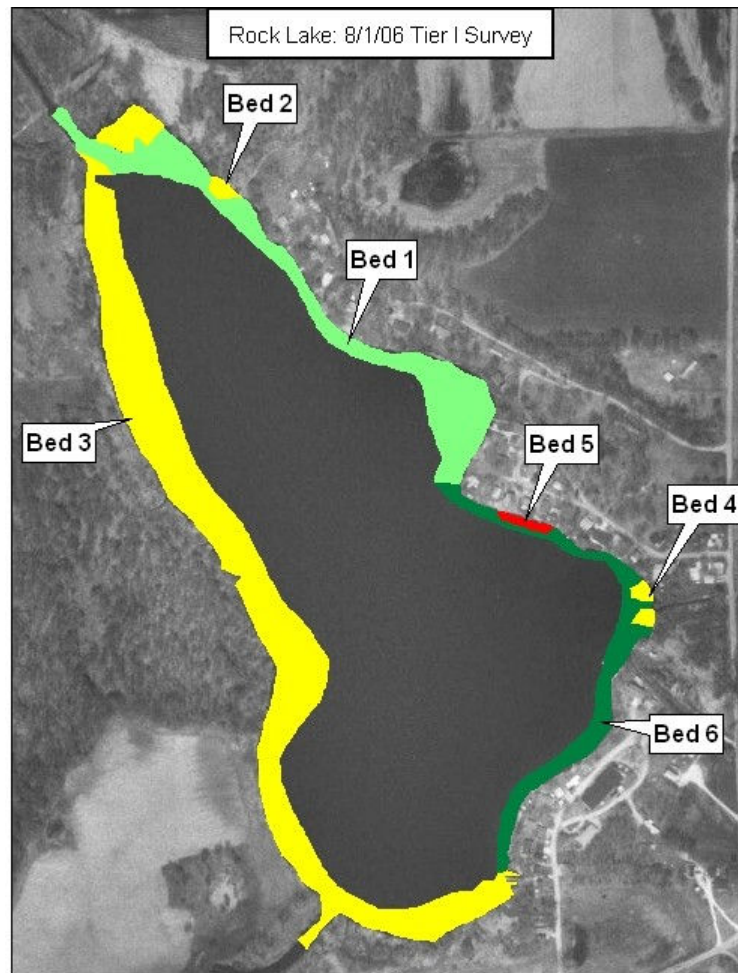
Figure 2. Tier I Plant Beds, Rock Lake, August 1, 2006

On August 1, 2006, a Tier I survey was completed on Rock Lake. The Tier I survey revealed six distinct plant beds totaling 15.2 acres (Table 2 & Figure 2). Seven different species were observed.

Plant bed 1 was located along the northeast shoreline of Rock Lake (Figure 2). It was determined to be 3.7 acres in size. A total of seven species were observed within the plant bed. White water lily was the dominant plant species. Spatterdock, sago pondweed, bulrush, water willow, common cattail, and blueflag iris were observed at the lowest abundance rating.

Plant bed 2 was located in the northeast corner of Rock Lake (Figure 2). This plant bed was determined to be 0.1 acres and was dominated by rooted floating vegetation. Spatterdock was the most dominant species. White water lily, bulrush, and water willow were also present.

Plant bed 3 was located on the western shoreline (Figure 2). Bed 3 was the largest plant bed at 9.2 acres and was dominated by rooted floating vegetation. A total of five plant species were observed in plant bed 3. Spatterdock was the most abundant species with a score of 4. White water lily was the second most abundant species with a score of 3. Sago pondweed, common cattail, and bulrush were also observed at lower abundance.

Plant bed 4 was located on the southeast side of Rock Lake (Figure 2). Bed 4 was found to be 0.1 acres and contained five different species. Spatterdock was the most abundant

species followed by white water lily. Sago pondweed, water willow, and bulrush were also observed.

Plant bed 5 was located just north of plant bed 4 along the eastern shore of Rock Lake (Figure 2). Bed 5 was found to be 0.1 acres and 4 species were observed. Sago pondweed was the most abundant species followed by white water lily. Bulrush and water willow were observed at the lowest abundance rating. Bed 5 was the only bed that had dense submersed vegetation growth.

Plant bed 6 was located in the southeastern corner of Rock Lake. This bed was found to be 2.0 acres. White water lily was the most abundant plant species observed. Sago pondweed, water willow, and bulrush were observed at the lowest abundance rating.

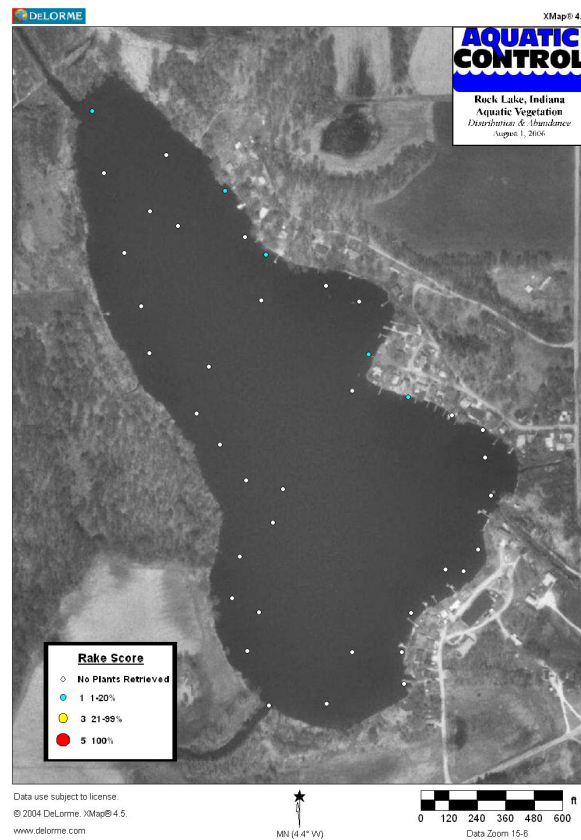
Figure 3. Location and density of aquatic vegetation, Rock Lake, August 1, 2006 (highest score was 1 which is represented by small light blue dot).

Tier II sampling took place on August 1, 2006 immediately following the Tier I sampling. A Secchi disk reading was taken prior to sampling, and was found to be 1.5 feet. Plants were present to a maximum depth of 4 feet. Forty sites were randomly selected within the littoral zone. Results of the sampling are listed in Table 3. The bottom half of Table 3 illustrates the frequency of occurrence and dominance of individual species. Vegetation was present at only five of the sample sites (Figure 3). The maximum number of species collected per site was 1.

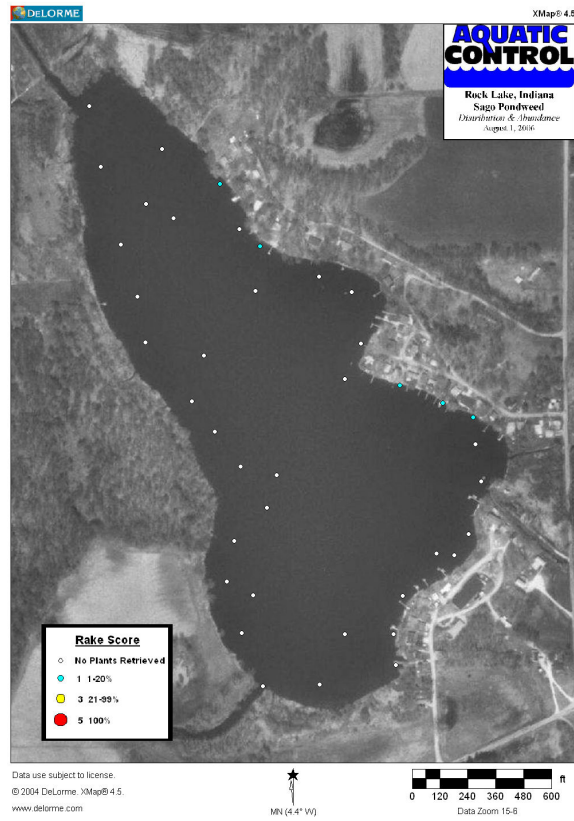
Figure 4. Location and density of sago pondweed, Rock Lake, August 1, 2006

Only three species were collected: sago pondweed, small pondweed (*Potamogeton pusillis*) and common coontail. Sago pondweed had the highest frequency of occurrence (12.5) and dominance index (2.5). Location and density of sago pondweed is illustrated in Figure 4 (in species location and density figures, plant location is illustrated by a color coded dot, the color and size of the dot represents the density of the species, and sample sites without that species are illustrated by smaller white diamond). Common coontail was the second most abundant species collected and location and density of this species is illustrated in Figure 5. No invasive exotic species were collected.

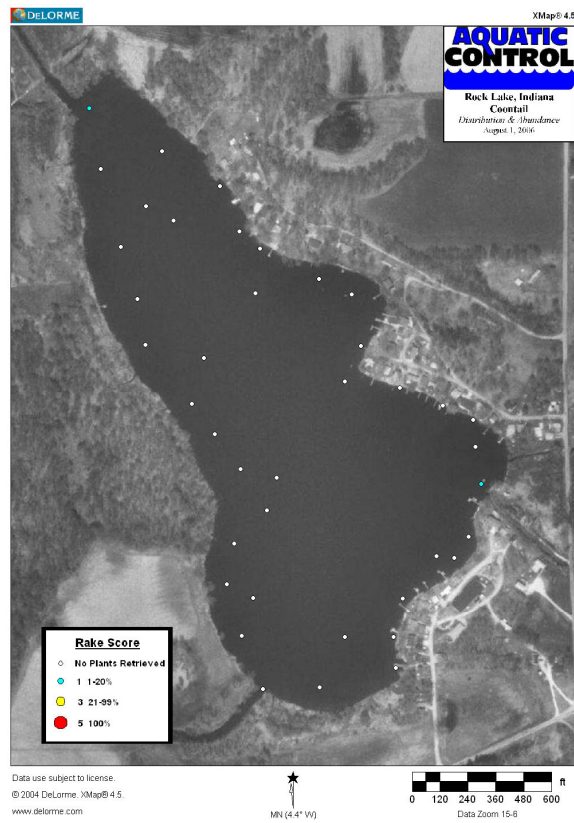
Figure 5. Location and density of common coontail, Rock Lake, August 1, 2006

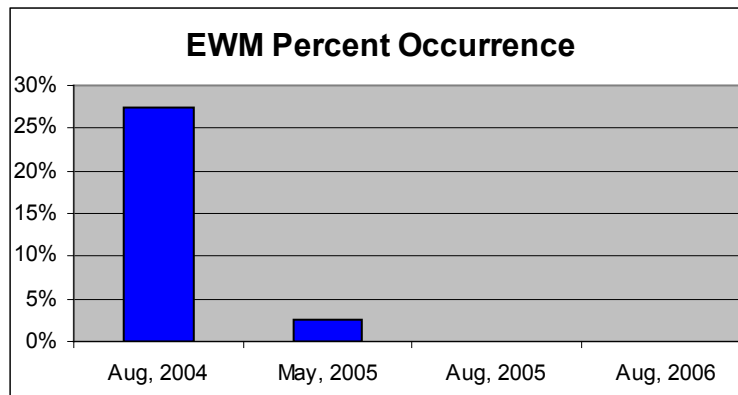
Figure 6. Rock Lake, comparison of Eurasian watermilfoil frequency of occurrence in the last four Tier II surveys.

One of the main goals of the aquatic vegetation management plan is to control the negative impacts of aquatic invasive species. It appears that this goal was met again in the 2006 season. In the 2004 Tier II survey milfoil was found at 27.5% of sample sites. Milfoil was treated in the spring of 2005 with Renovate herbicide. No milfoil was detected in August of 2005 or August 2006 (Figure 6).

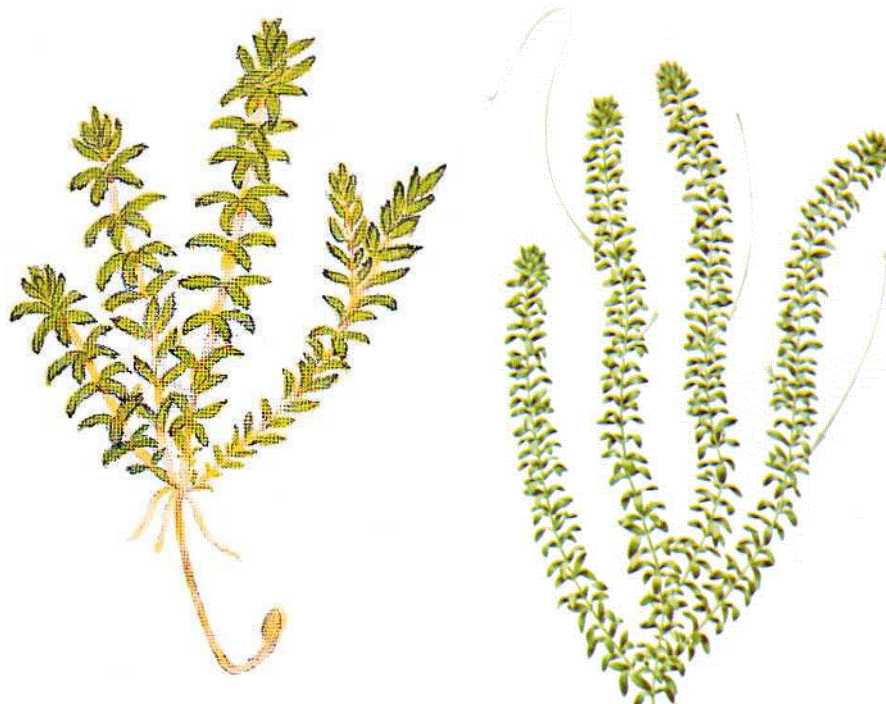
Figure 7. Illustration of Hydrilla on the left compared to native elodea on the right. Hydrilla typically contains five toothed leaves per whorl while native elodea typically has three leaves per whorl and the teeth are not visible on the leaves (Illustrations provided by Applied Biochemist).

Another topic discussed at the public meeting was the recent discovery of Hydrilla (*Hydrilla verticillata*) in Lake Manitou. Hydrilla is an invasive aquatic species that was originally discovered in Florida in the 1960's. There are many characteristics of hydrilla that make it a threat to Indiana waterways. This species can grow in lower light conditions than most native species, grows faster than most native species, and can shade out other species by forming a surface canopy. Hydrilla can be easily confused with native elodea. The best way to distinguish Hydrilla from native elodea is that Hydrilla typically has five leaves along each whorl along with visible serrated edges along the leaf margin (Figure 14). What makes controlling the spread of Hydrilla difficult is the fact that it can be spread by fragments. **That is why it is vitally important that lake users remove all plants and sediment from their boats when entering and leaving Rock Lake.** More information about controlling the spread of Hydrilla can be found at www.protectyourwaters.net.
